| <br><b>NGDV – Technical Bulletin</b> | <b>Title:</b> Battery Cable Routing Guidance | |
| | <b>Number:</b> NGDVTB018 | <b>Revision:</b> - |

## Battery Cable Routing Guidance

## NGDVTB018 – BATTERY CABLE ROUTING GUIDANCE

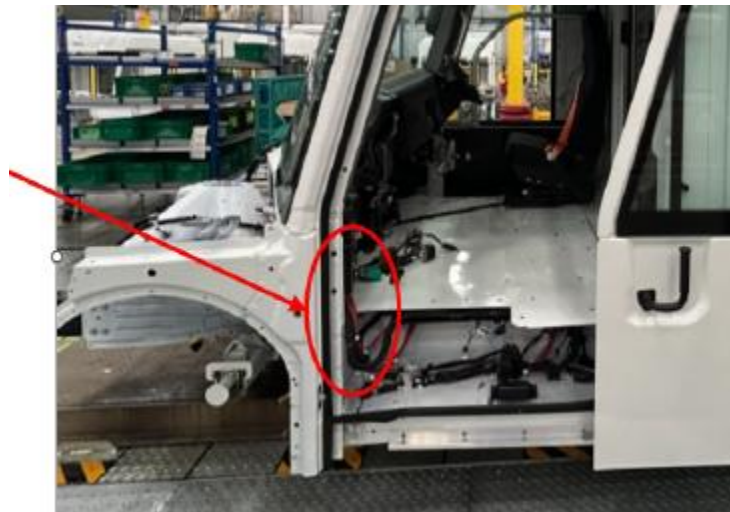
*Image 1*

Inspect the routing of the battery cables (Negative & Positive) in the battery well near the A-pillar on the Road Side of the vehicle. Verify the Red Cable (Positive) is positioned inboard, toward the vehicle interior and does not contact, rub against or is pinched by the unibody edge as seen below in *Image 1*.

When the red cable is secured inboard to the black cable as seen in *Image 1*; the rework is complete and a warranty claim can be submitted for the time and materials listed at the beginning of this Technical Bulletin. There still may be “twist” in the cables due to routing variations which is acceptable.

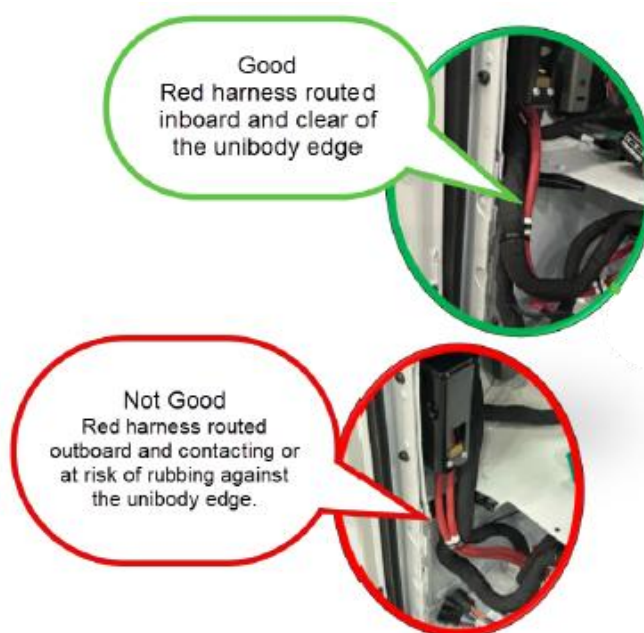
*Image 2*

If the routing does not look like *Image 1* or the “Good” picture below in *Image 2*, then the existing cable tie (refer to *Image 3*) must be removed and the red cable positioned inboard and secured with a new cable tie to position the red cable away from the unibody.
